Manhole Inspection Summary

Manhole # S37M__010MH

Inspection ☐ Is Incomplete Rating: **3) Fair**

Location Address: **801 key hw**

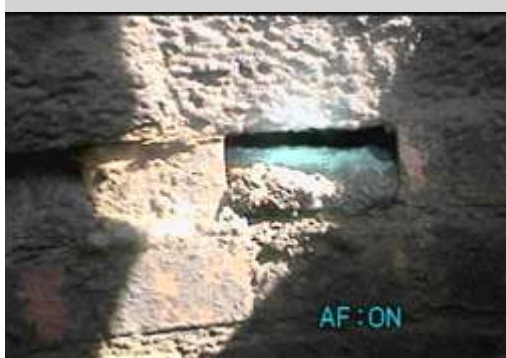
Defect 3

Condition: ☐ Sound ☐ Cracked ☐ Root Intrusion ☒ **Loose Brick** ☒ **Deteriorated**

chimney cond loose bricks, chimney cond deteriorated

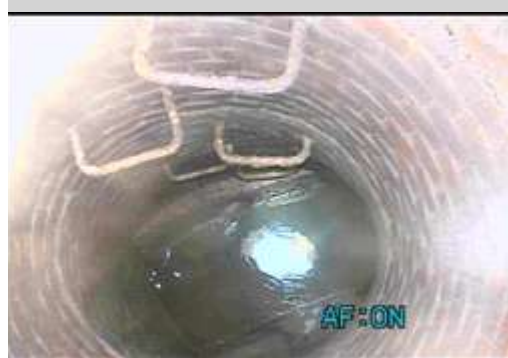
Defect 2

Count: **6** Missing: **0** ☒ **Corroded**

corr steps

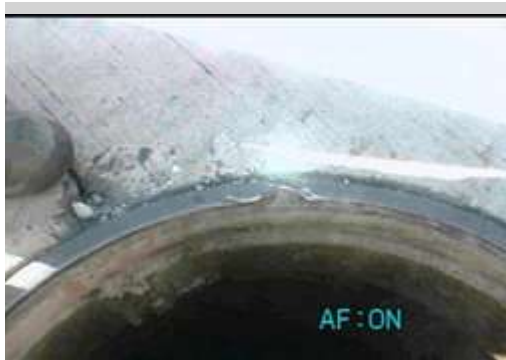
Defect 1

Condition: ☐ Sound ☒ **Cracked** ☐ Leaks

frame cracked

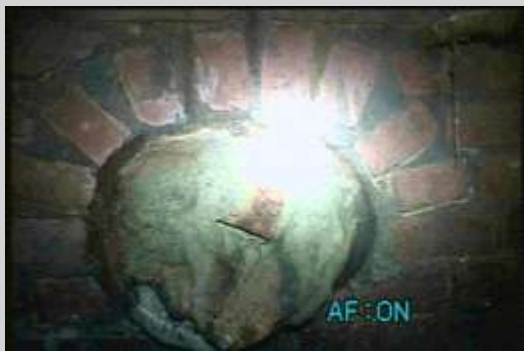
3 O'Clock Inflow

closed off
